Case Study

Project Name: *Tejgoan Fire Brigade retrofitting, Dhaka, Bangladesh.*

Client: **Public Works Department**
Year of Completion: **2014**
Renovation

Contractor *Nutech Construction Chemicals Company Ltd,*
City or Region & Country: **Dhaka, Bangladesh.**

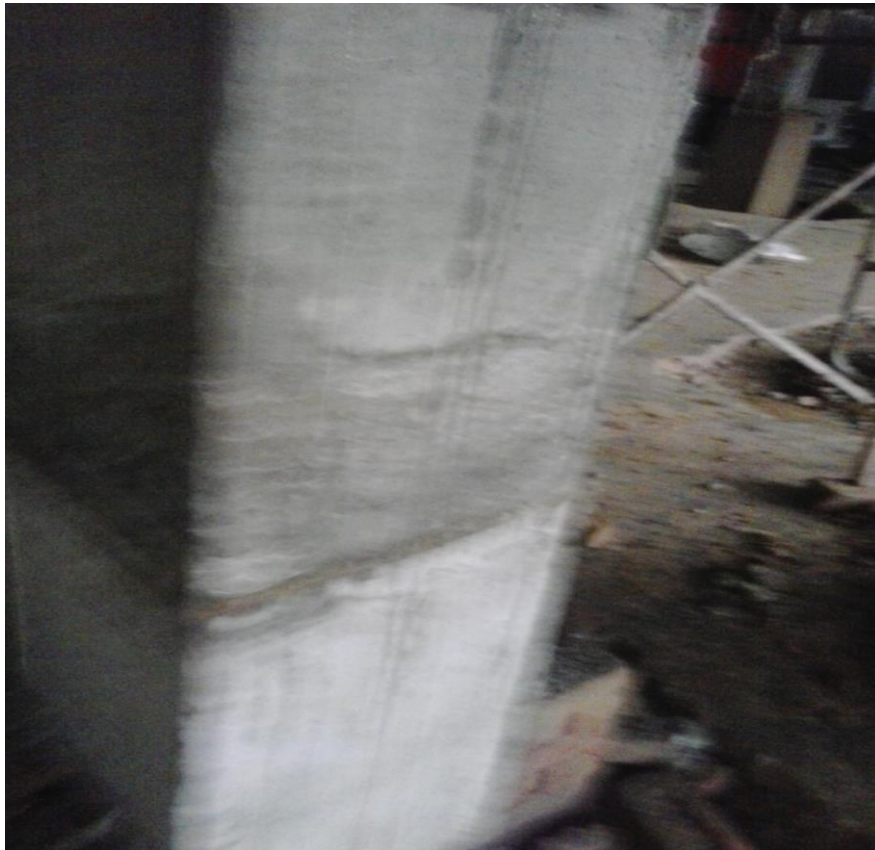
Fig: Column After Micro Concrete Encasement

- Rectification of Column and beams by micro concrete Encasement.
- Filling cracks of slab, column and beams by Nitofill EPLV.
- Installation of shear connector at slab, beam and column by Lokfix.
- The dilapidated Fire Brigade building is under designed and government identified the same as most vulnerable government building but was not possible owing to alternative accommodation but Fosroc Proposed a retrofitting measures by Micro concrete encasement of its structural members without much interrupting the regular working environment.
- Fosroc Repair & Remediation solutions were recommended and used for repairing
- Materials used included Fosroc Nitofill EPLV, Fosroc Renderoc Renderoc RG , Fosroc Conbextra GP2, Fosroc Nitobond EP, Lokfix, Concure LP 90, Reebol Emulsion Xtra.

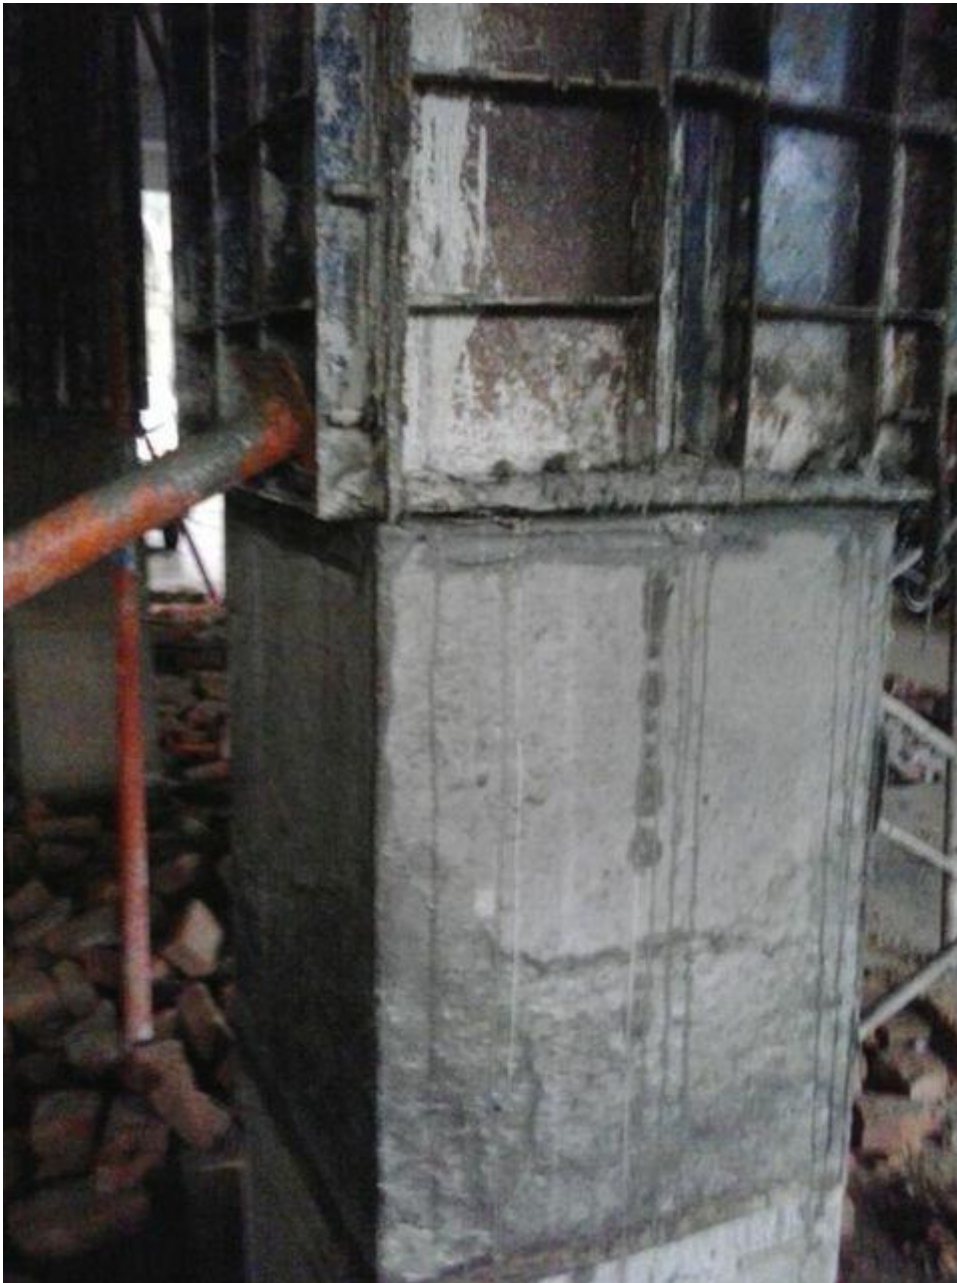
Fig: Column after Micro Concrete Encasement
