Judge court building retrofitting, Bagherhat, Khulna, Bangladesh. **Project Name:**

Client: **Public Works Department**

Renovation

Rectification of Column, beams and slabs by micro concreting.

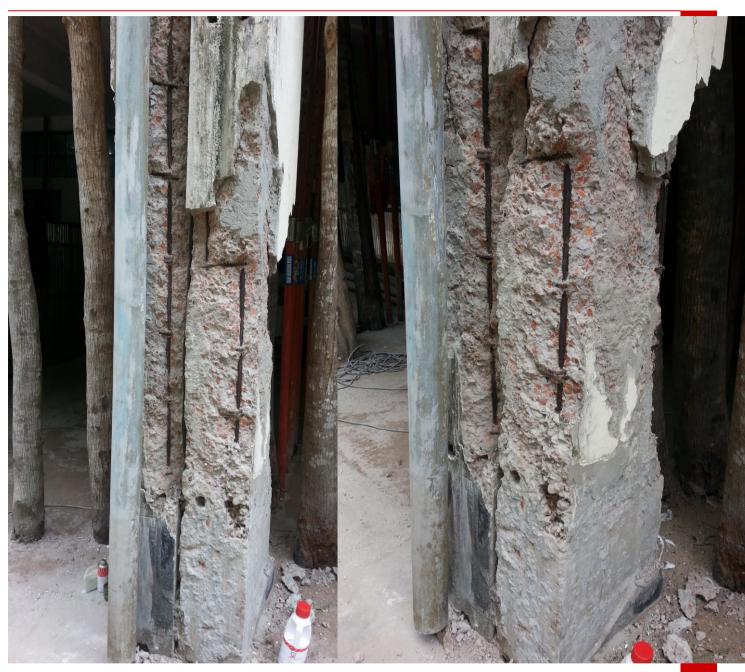
History: Judge court building constructed in 1995 but severe corrosion deposits observed owing to poor quality of concrete and it falls in saline belt. The PWD department decided it to demolished but Fosroc and Fosroc Associates proposed to retrofit the same without much interruption of regular environment. To convince customer, many of the sites have been visited by PWD officials and later decided to retrofit the same with Fosroc Renderoc RG and ancillary products.

Photo-1: column before retrofitting Photo-2: columns before retrofitting

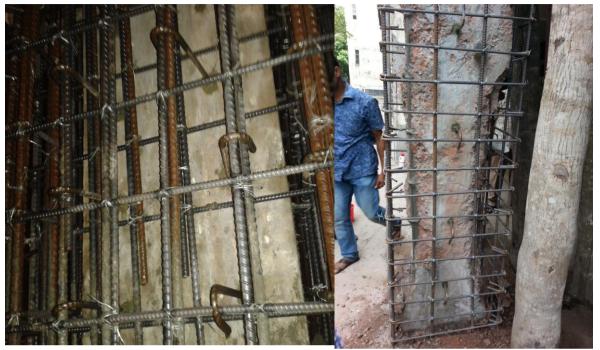
Photo-3: columns during retrofitting phases

Photo-4: columns during retrofitting phase

Filling cracks of slab, column and beams by Nitofill EPLV.

Installation of shear connector at slab, beam and column by Lokfix.

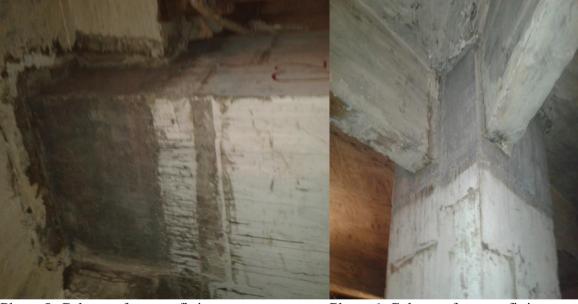
Photo-5: Column after retrofitting

Photo-6: Column after retrofitting
