Case Study

Project Name: *Judge court building retrofitting, Bagherhat, Khulna, Bangladesh.*

Client: **Public Works Department**
Year of Completion: **2014**
Renovation

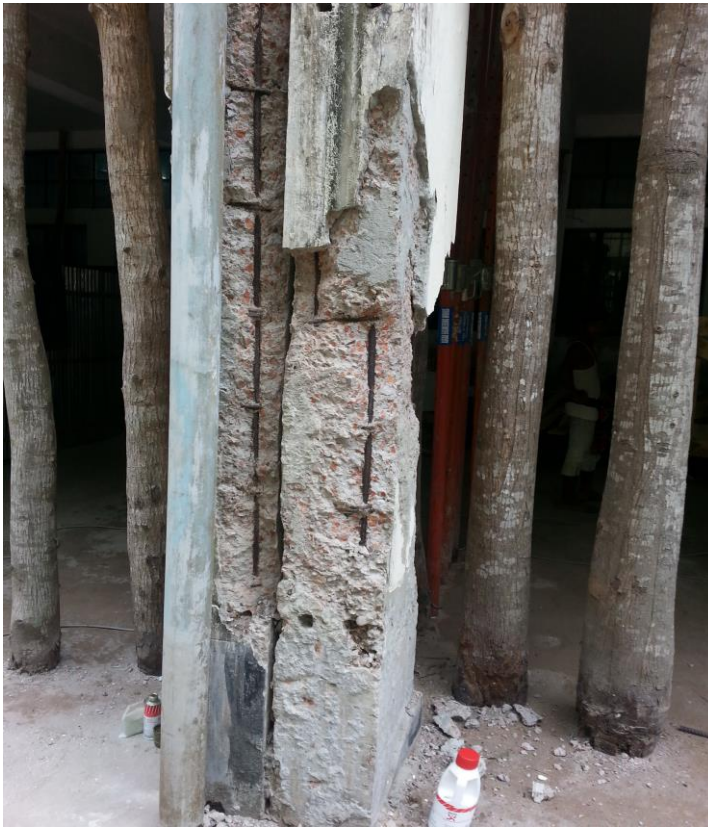
Fig: Dilapidated columns

- Rectification of Column , beams and slabs by micro concreting.
- Filling cracks of slab, column and beams by Nitofill EPLV.
- Installation of shear connector at slab, beam and column by Lokfix.
- The judge court building was supposed to be dilapidated owing to cracks, spalling but Fosroc Proposed a retrofitting measures by Micro concrete encasement of its structural members, finally the relevant references convince customer to retrofit instead of damaging without much interrupting the regular working environment.
- Fosroc Repair & Remediation solutions were recommended and used for repairing
- Materials used included Fosroc Nitofill EPLV, Fosroc Renderoc Renderoc RG , Fosroc Conbextra GP2, Fosroc Nitobond EP, Lokfix, Concure LP 90, Reebol Emulsion Xtra.

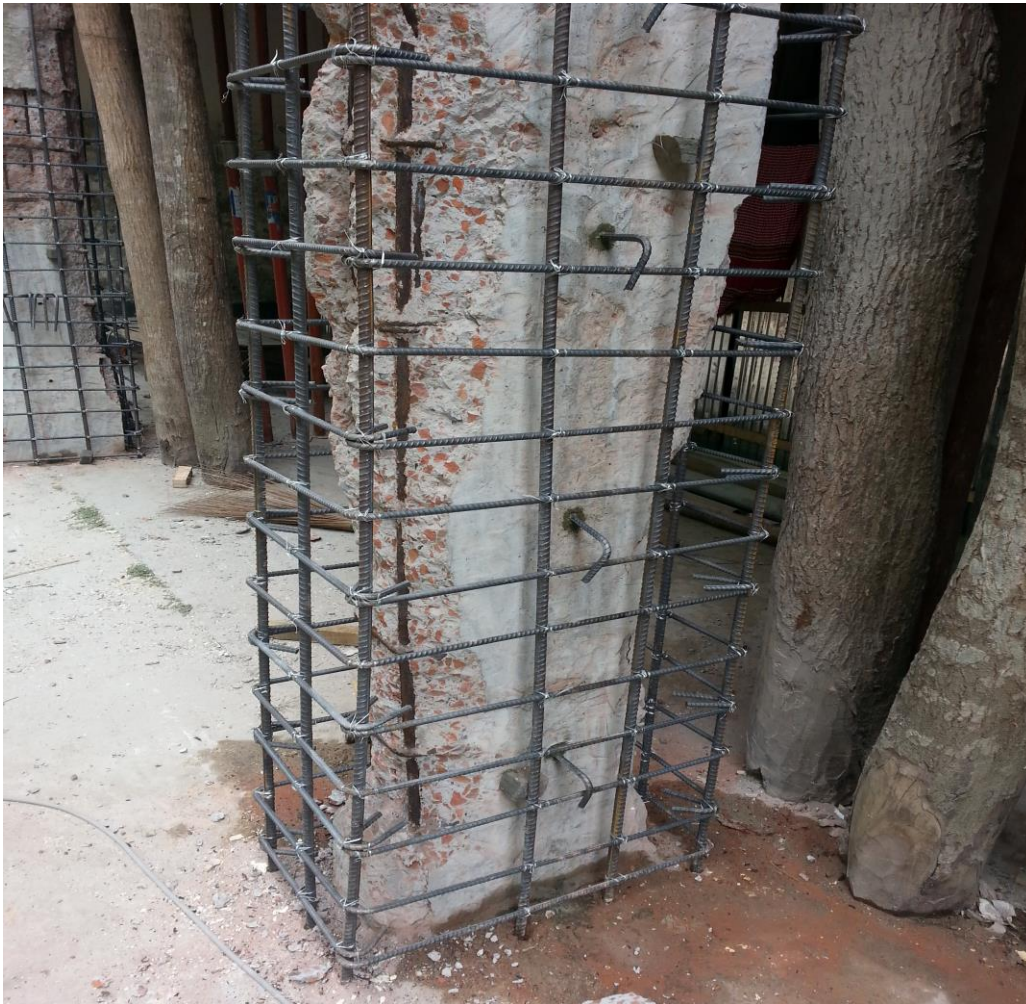
Photo: Column During retrofitting

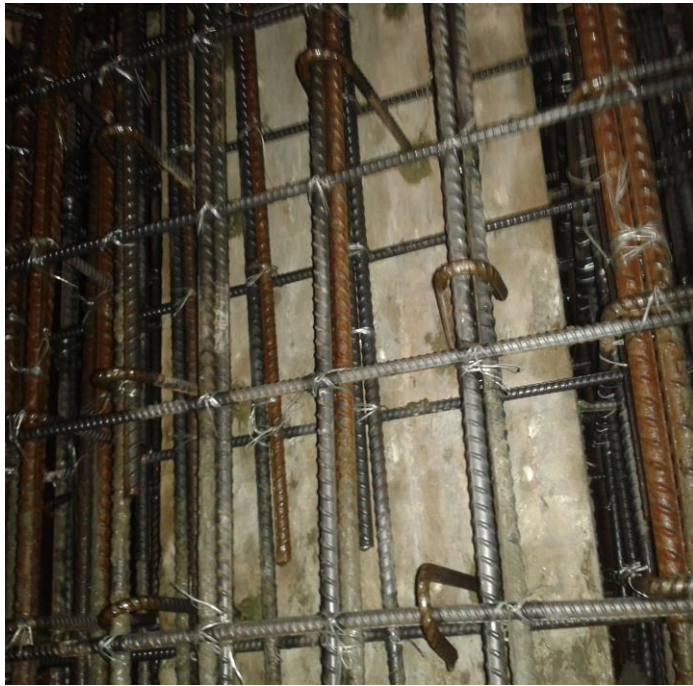
Photo: columns during retrofitting phases

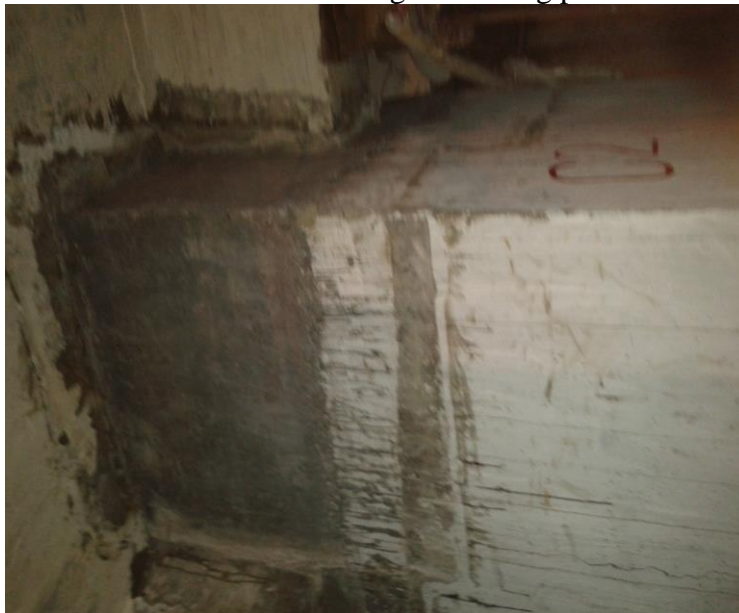
Photo: Column after retrofitting
