Case Study

Project Name: *Squire Toiletries Ltd, Rupganj, Narayanganj, Bangladesh.*

Client: **Squire Group, www.squiregroup.com**
Year of Completion: **2014**
Renovation

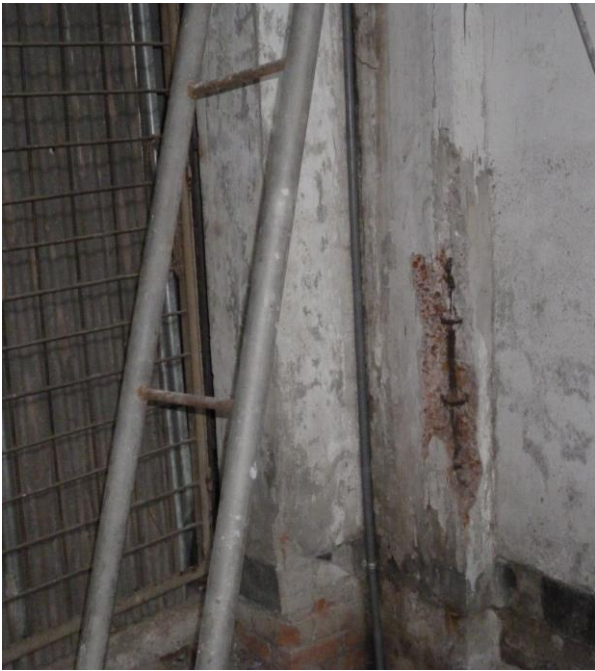
Photo-1: column before retrofitting

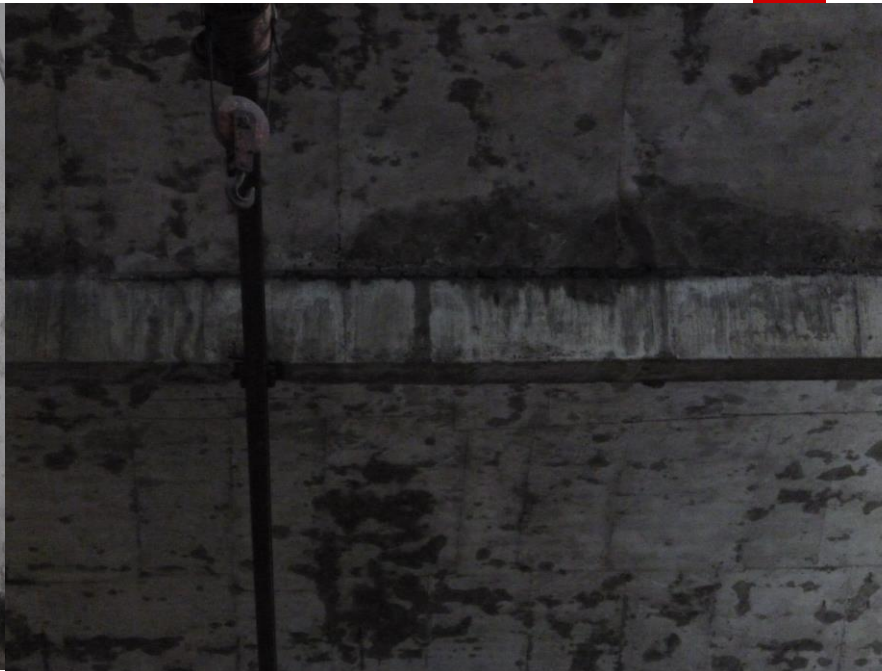
Photo-2: Cracked Section of Beams

- Rectification of Column , beams and slabs by micro concreting.
- Increasing flexural capacity of beams
- Filling cracks of slab, column and beams by Nitofill EPLV.
- Installation of shear connector at slab, beam and column by Lokfix.
- Fosroc Proposed Renderoc RG (Micro Concrete) instead of regular Concrete as specified by consultants to match 40 Mpa existing concrete of existing columns & Beams.
- Fosroc Repair & Remediation solutions were recommended and used for repairing
- Materials used included Fosroc Nitofill EPLV, Fosroc Renderoc Renderoc RG , Fosroc Conbextra GP2, Fosroc Nitobond EP, Lokfix, Concure LP 90, Reebol Emulsion Xtra.

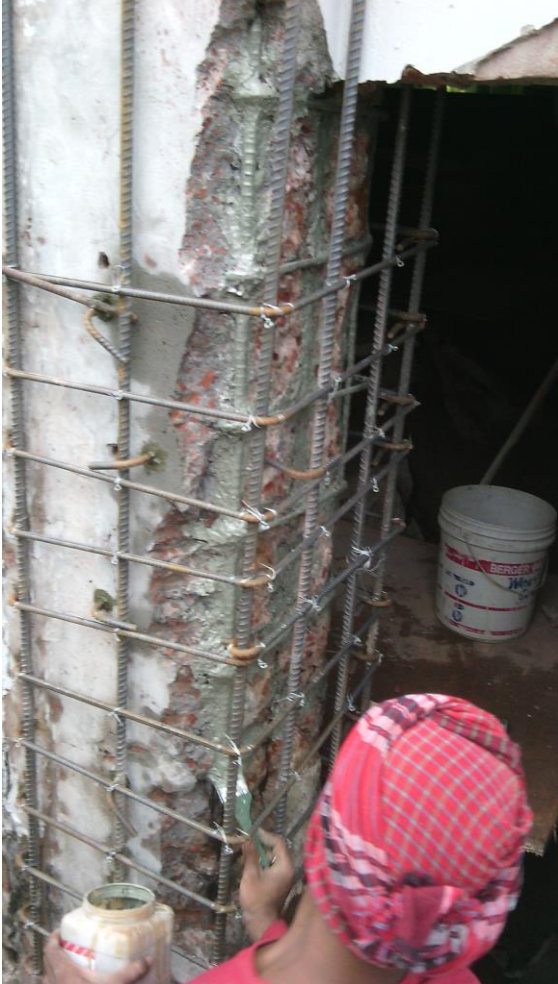
Photo-3: Columns During Retrofitting

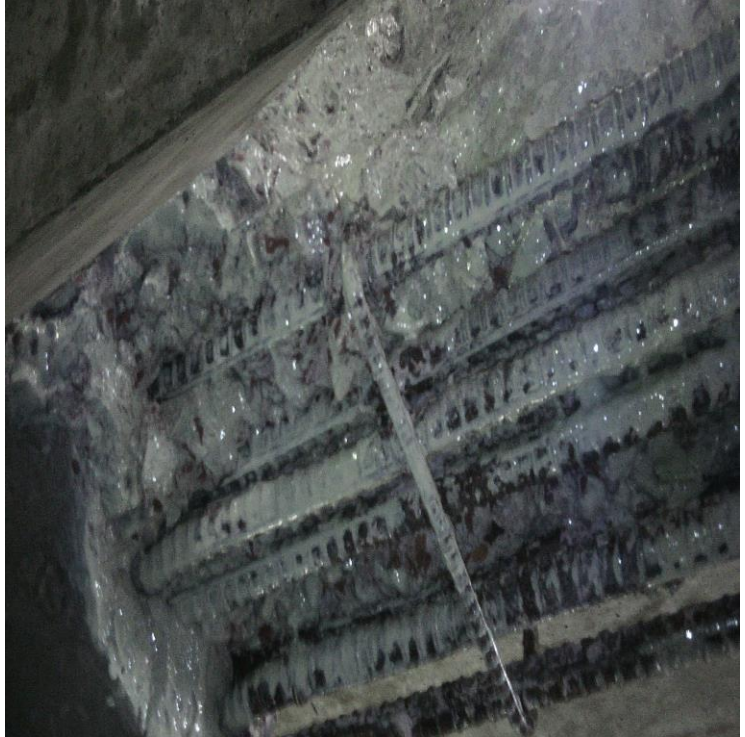
Photo-4: Beams During Retrofitting

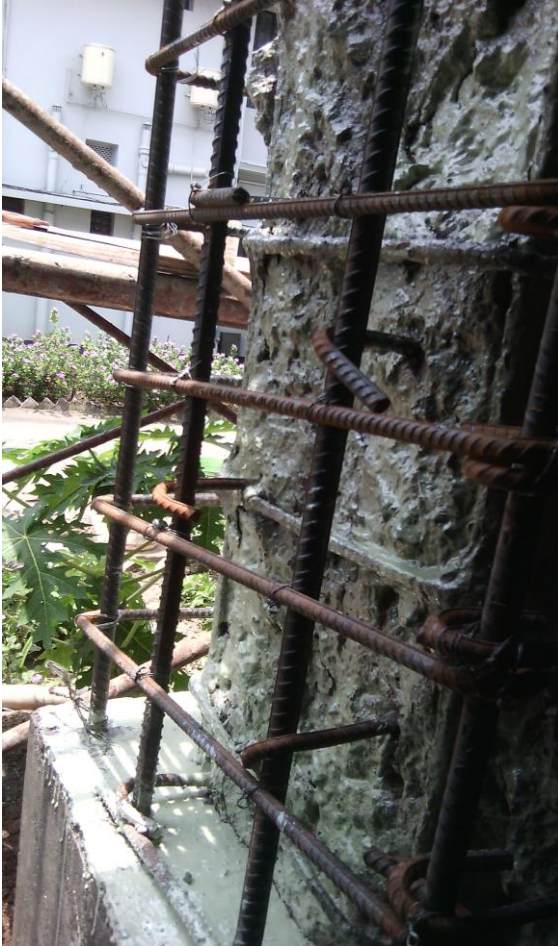
Photo-5: Column During Retrofitting

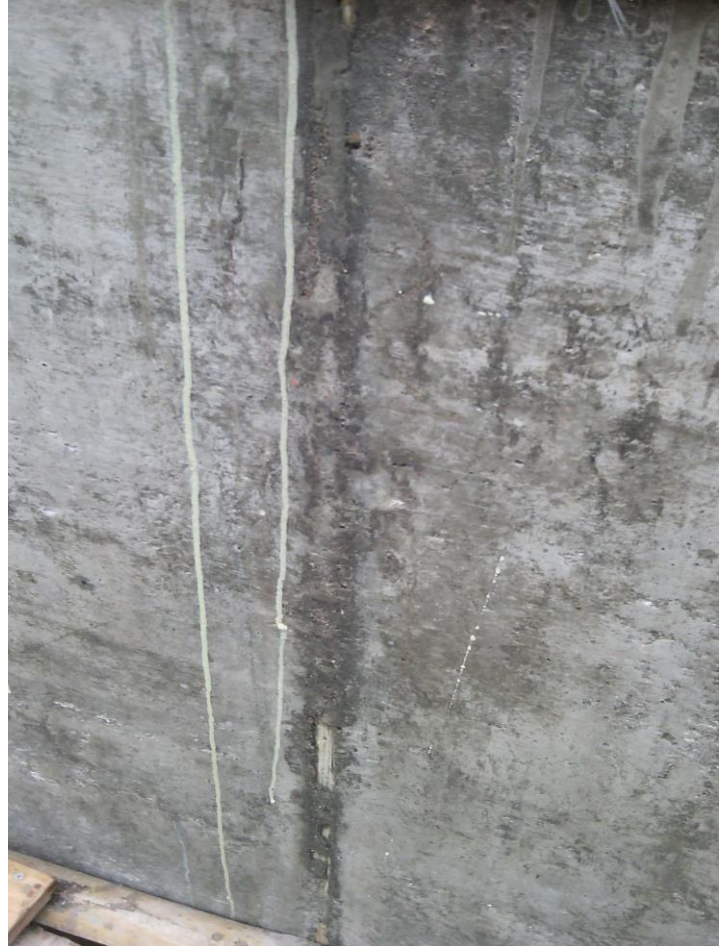
Photo-6: Column after retrofitting
