Case history

Industry	Infrastructure
Project	Sagar Building
Location	Mumbai
Completion date	1999-2000
Consultant	Fosroc
Contractor	Precision Engineers, Mumbai
Products	Nitozinc Primer, Lokset, Renderoc RG(L), Nitobond AR, Concure WB

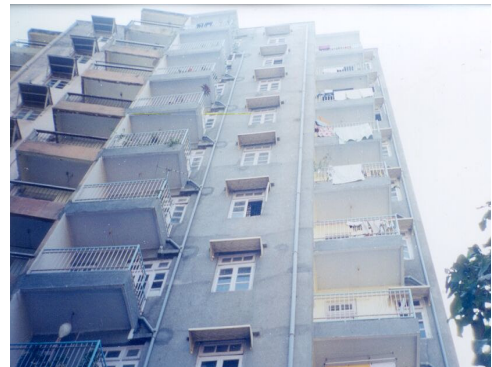
Before application

Sagar Building is a 10-storied building constructed about 25 years ago. This building had developed severe corrosion problems due to chloride attack & carbonation. The distress noticed was cracking, spalling napping of ties etc.

The solution was based on the systematic approach. It comprises of, thorough surface preparation, removal of weak/damaged concrete, cleaning of steel and provision of extra reinforcements, provision of anticorrosive coating, fixing of shear connectors and application of acrylic bonding agent and encasement with fluid micro concrete. Curing was done by using wax based curing compound.

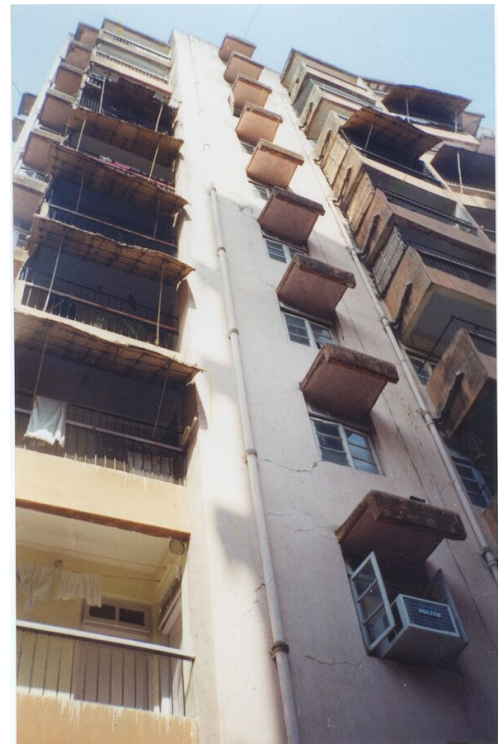
After application
